#### **Arkema Facility - Harvey Response**

Arkema Inc.

September 8, 2017

Project #109489 Summary

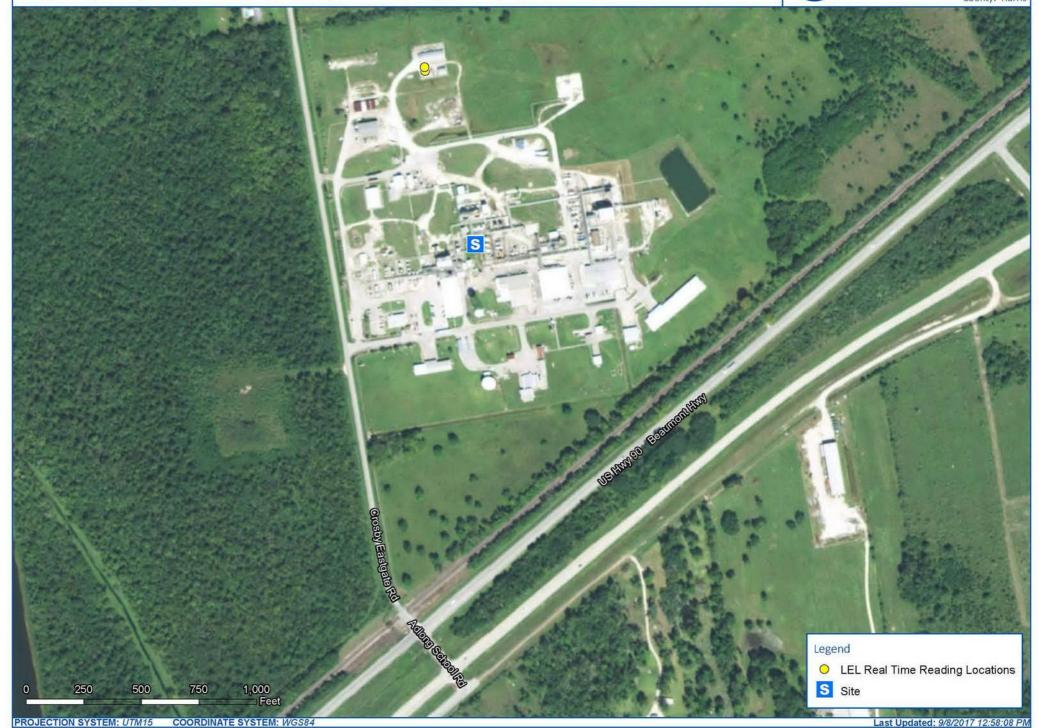
#### LEL Hand-held Real-time Reading Locations - Worker Activity

Analyte	Instrument	Number of Readings	Number of Detections	Range of Detections*		
LEL	MultiRAE	2	0	< 1.0 %		
O <sub>2</sub>	MultiRAE	1	1	20.9 %		
VOCs	MultiRAE	6	0	< 0.1 ppm

Harvey Response - 06:00 September 7, 2017 to 06:00 September 8, 2017

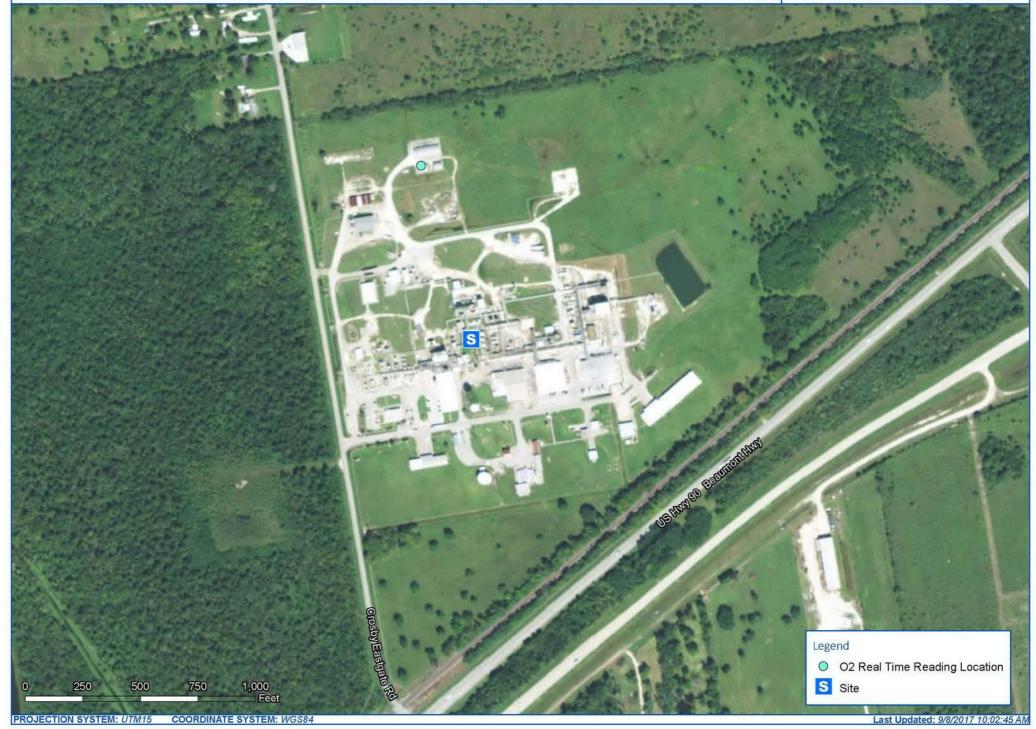
#### Oxygen Hand-held Real-time Reading Locations - Worker Activity

Harvey Response - 06:00 September 7, 2017 to 06:00 September 8, 2017

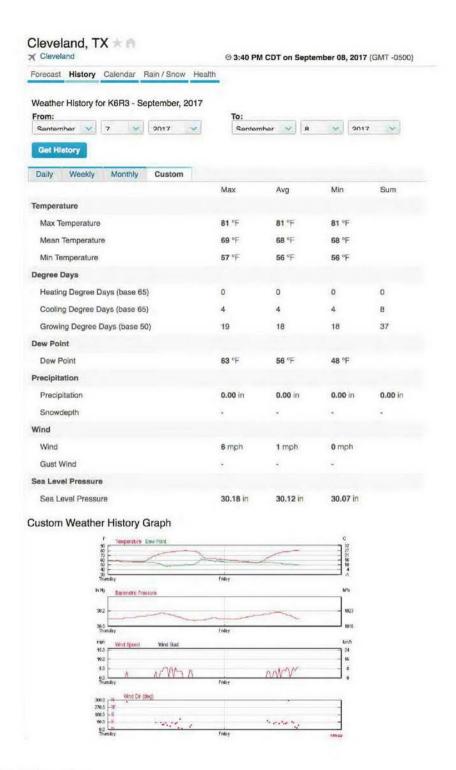
(Cleveland Municipal Airport - 27.3 miles North of Site)

#### Weather History & Observations

2017 Temp. (°F) D		Dew F	w Point (°F) Humidity (%)			Sea Level Press. (in)			Visibility (mi)		Wind (mph)			Precip. (in)	Events					
Sep	high	avg	low	high	avg	low	high	avg	low	high	avg	low	high	avg	low	high	avg	high	sum	
7	81	69	57	63	56	48	96	70	32	30.17	30.11	30.07	10	10	7	6	1	8	0.00	
8	81	68	56	58	55	51	96	72	34	30.18	30.13	30.09	10	9	7	6	1	~	0.00
